JOHN BOLLINGER NO. 1 DAM  
MADISON COUNTY, MISSOURI  
MO 51417

# PHASE 1 INSPECTION REPORT NATIONAL DAM SAFETY INSPECTION

DECEMBER 1980

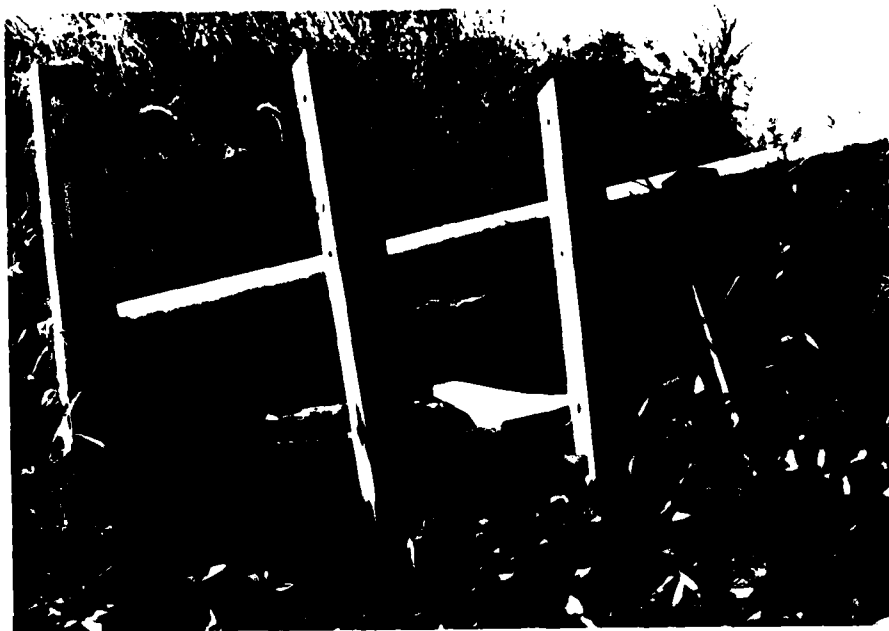
1. Main spillway. The main spillway consists of a 12-in. diameter asbestos-concrete pipe extending through the dam embankment. The inlet has a vertical riser with a crude trash rack to prevent congestion (Photo 7). The trash rack is fairly rough and the vertical beams are approximately 18 to 24 in. apart. However, the drainage basin is used exclusively for agriculture and there appears to be little chance for developing obstructions sufficient to block the pipe. No valves or controls were noted on the pipe. The outlet exits at the toe of the dam near the maximum section (Photo 8).

7. Inlet for main spillway pipe, with wooden beams acting as trash rack. Pipe is 12-in. diameter asbestos-concrete. Looking south.
